# *Reusable Solid Rocket Motor* **STS-106 Flight Readiness Review/CoFR**

*Motor Set RSRM-75*

**29 August 2000**

## Disassembly Evaluation Summary—In-Flight Anomaly (IFA) STS-101-M-01 STS-101 RH S&A Device Damaged A-M Actuator Armature Assembly (Ref. PAS DR4-5/315)

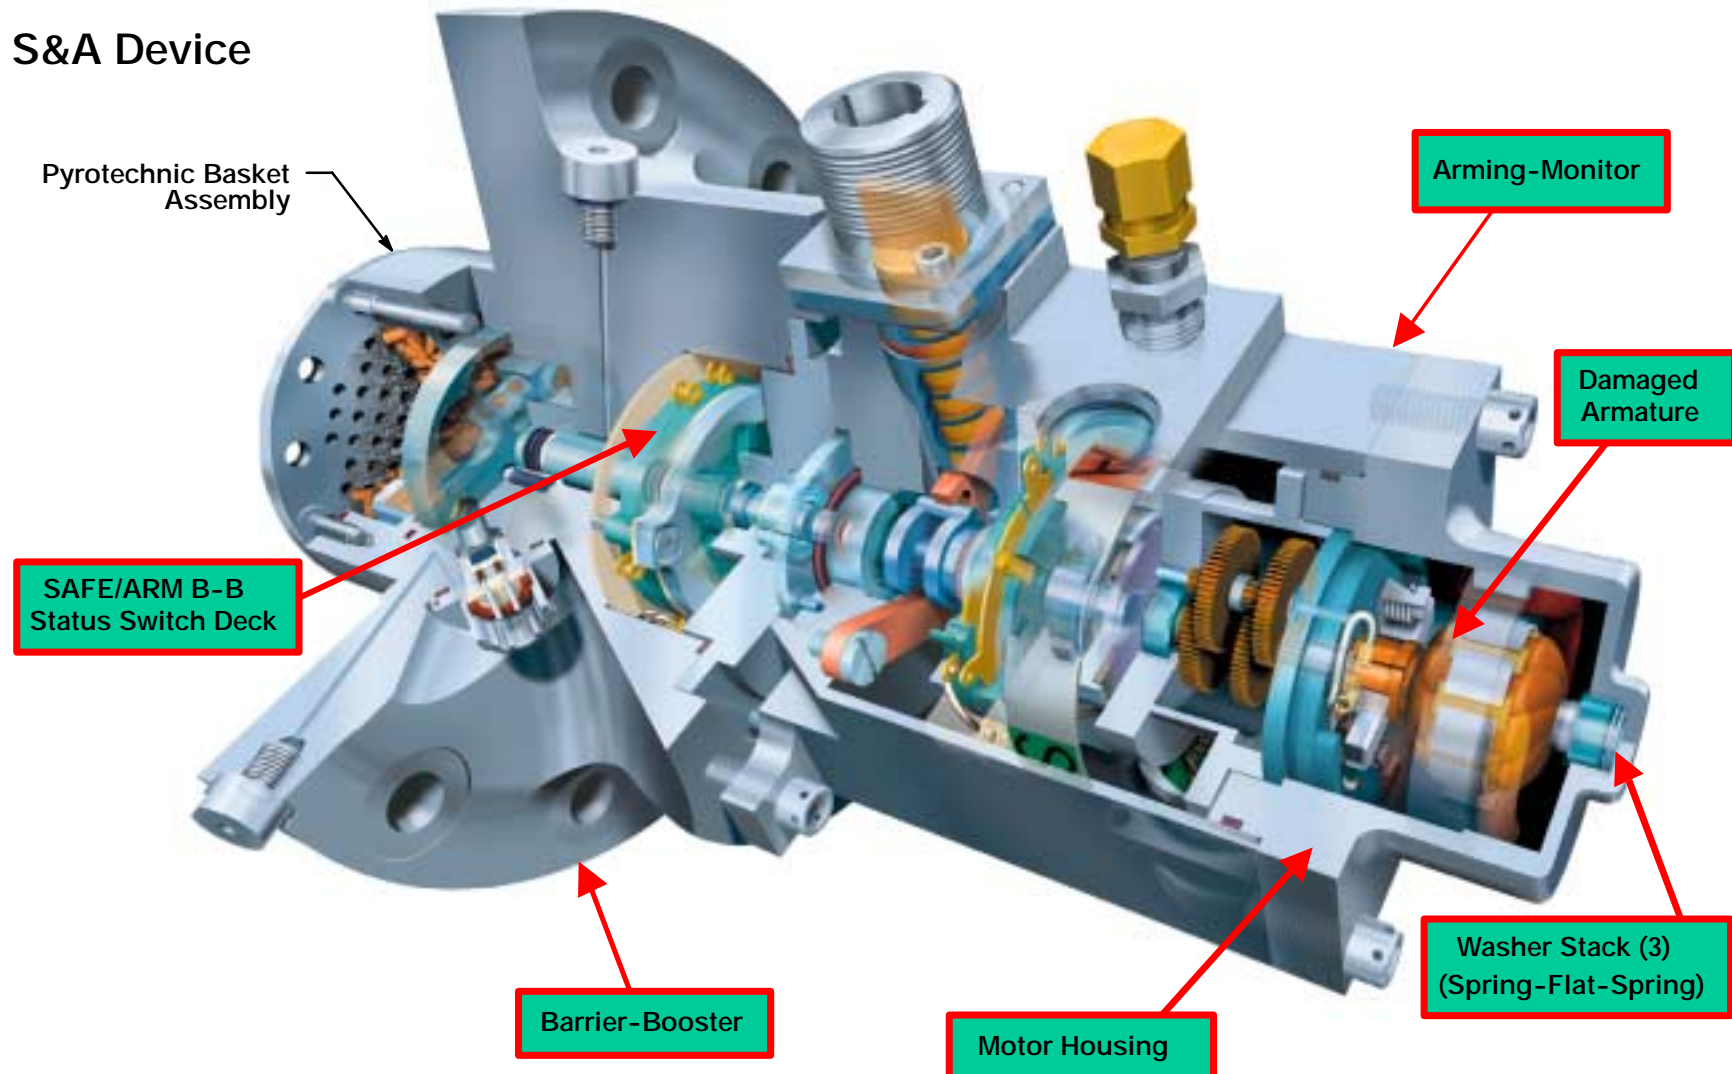
### S&A Device

- D During postflight electrical safing of the RH safe and arm (S&A) device arming monitor (A-M), rotation of the rotor drive train stopped prior to obtaining a SAFE indication
  - D Observed condition only affects S&A rotation
    - D No impact on ability of barrier-booster (B-B) to detect SAFE/ARM status
    - D No impact on pyrotechnic firing circuit
- D A-M manually rotated to SAFE position without mechanical interference
- D Subsequent disassembly showed damage to A-M motor
  - D Scraped and severed wires on motor armature
  - D Short-circuit between motor and A-M housing
  - D Spring washer lying in motor housing

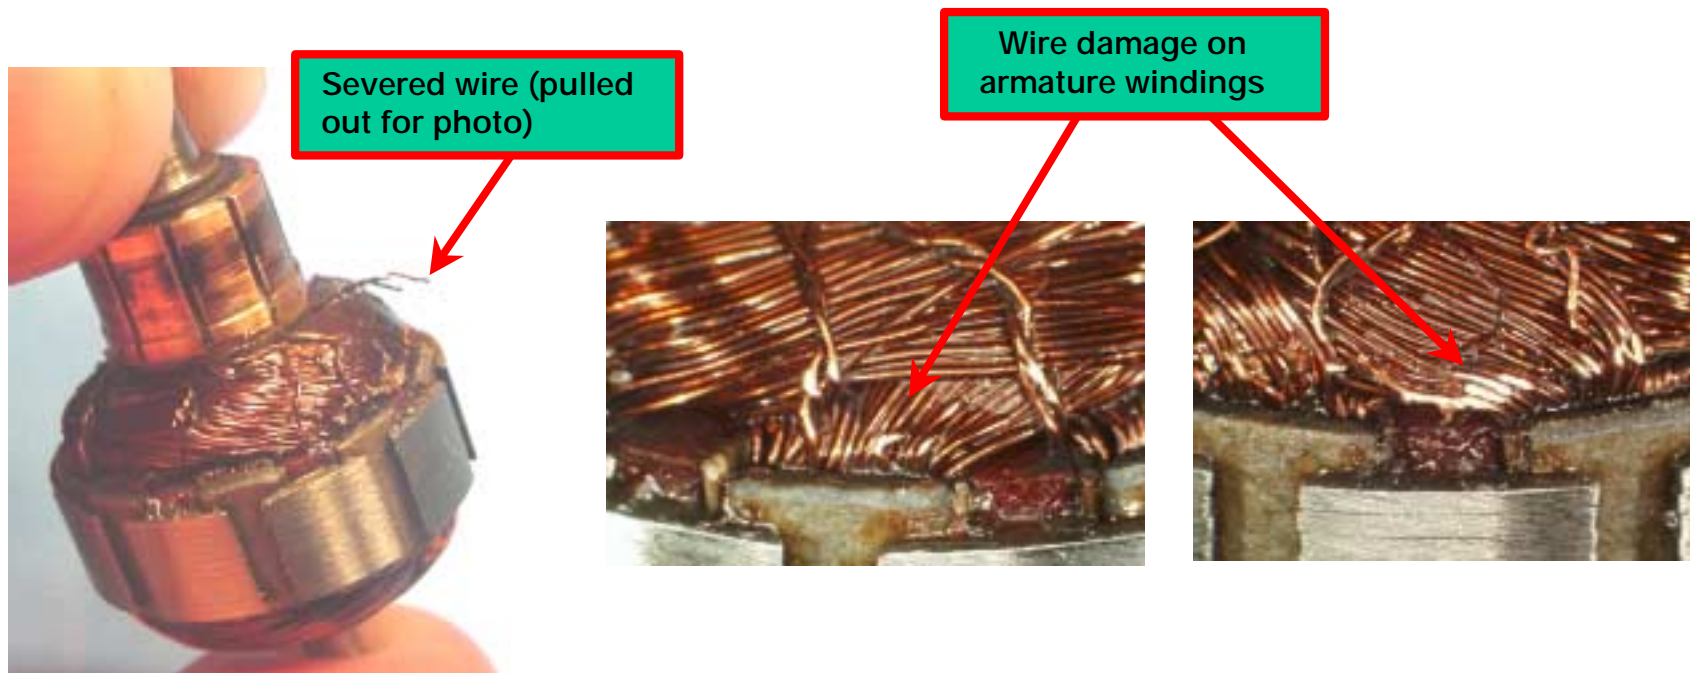
#### D Damaged A-M armature

- D MSFC/Thiokol/Supplier investigation team conducted fault tree analysis to determine cause of failure
  - D Inspection of A-M assembly indicated that A-M motor armature was the only damaged component

- D Unit was reassembled with new armature and passed all acceptance tests
- D A-M motor armature damage was determined to have been caused by out-of-place spring washer

- D Displaced spring washer noted during A-M disassembly
  - D Forensic testing identified spring washer (stainless steel) constituents on armature
  - D Failure recreated with intentionally misplaced spring washer

- D Spring washers are used to provide proper armature preload in A-M assembly
  - D Blind installation of motor armature/brush plate assembly allows possibility of displaced spring washer

- D Armature preload acceptance tests cannot be passed with displaced spring washer
  - D Out-of-sequence armature preload testing was determined to be the root cause quality escape

- D Supplier corrective actions have been defined to prevent reoccurrence
- D Definitive radiographic inspection technique developed to verify proper location of washers in A-M assembly

- D Cause of the A-M failure to SAFE is understood and isolated to the A-M assembly—the critical ARM/SAFE status indicating functions of the B-B assembly are not indicted
- D S&A units on STS-106 were removed and replaced with units verified to have proper spring washer stacks via radiographic inspection
- D STS-106 is safe to fly

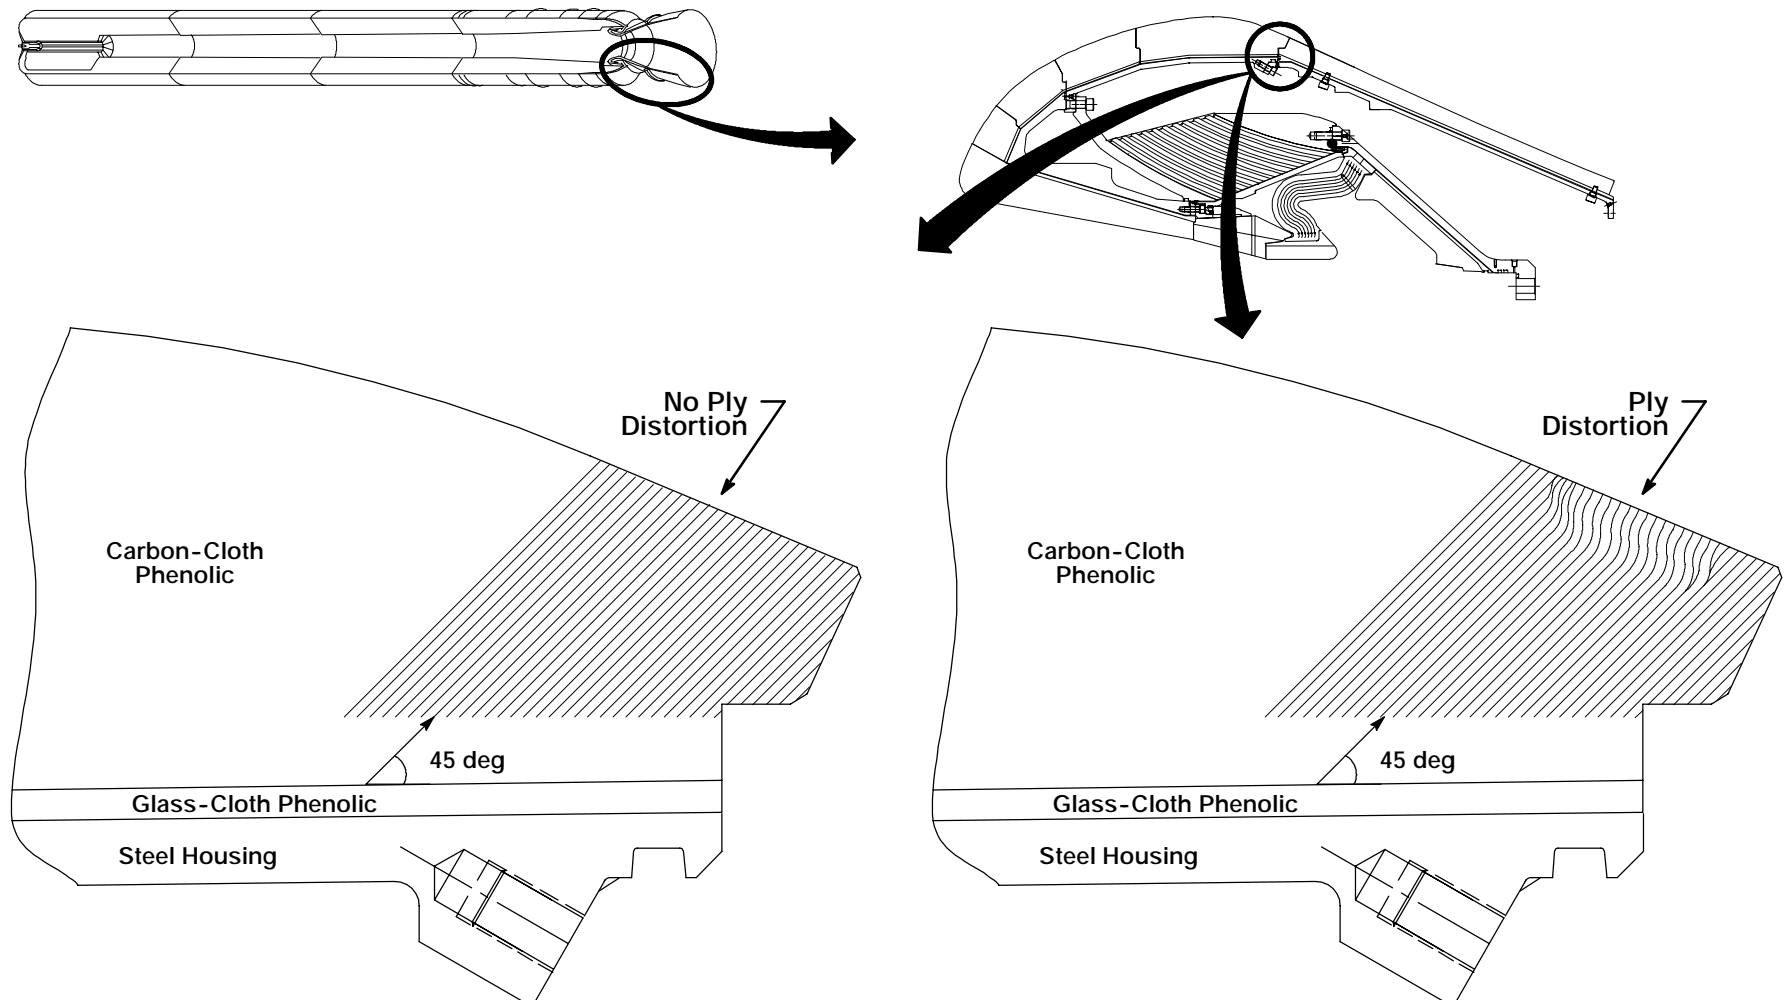
Cross Section of Nozzle and Ply Distortions

Nozzle pocketing erosion corrective action

Modified mandrel provides increased overstock in aft ID end of the throat ring billet—ply distortions subsequently machined away

Incorporate modified phenolic tape wrap mandrel (SAM) for fabricating nozzle throat rings. Inserted 1.9-in. spacer between forward and aft sections of existing mandrel
